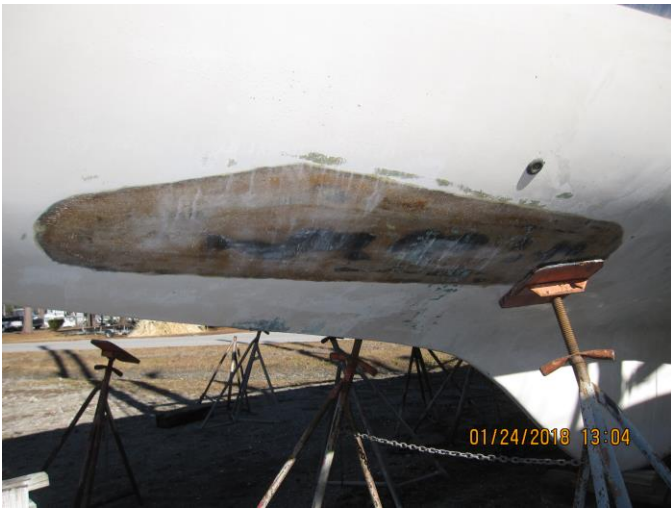
Detail of fiberglass hull repair, port side

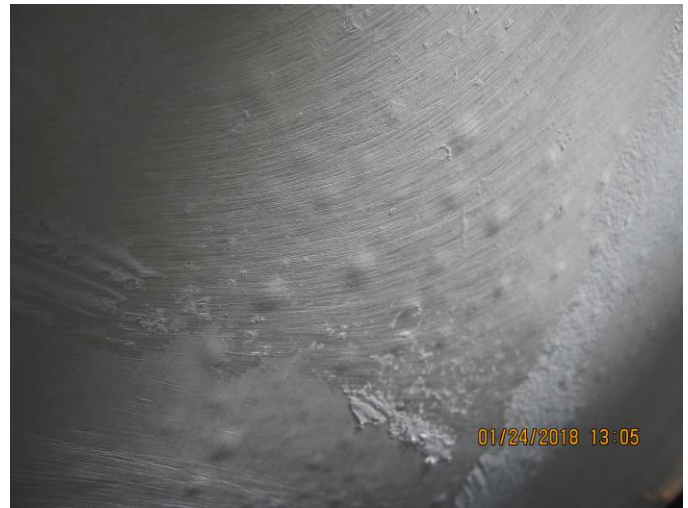
Dense very small diameter (3/8-inch) osmotic blisters, sporadically throughout wetted surface hull

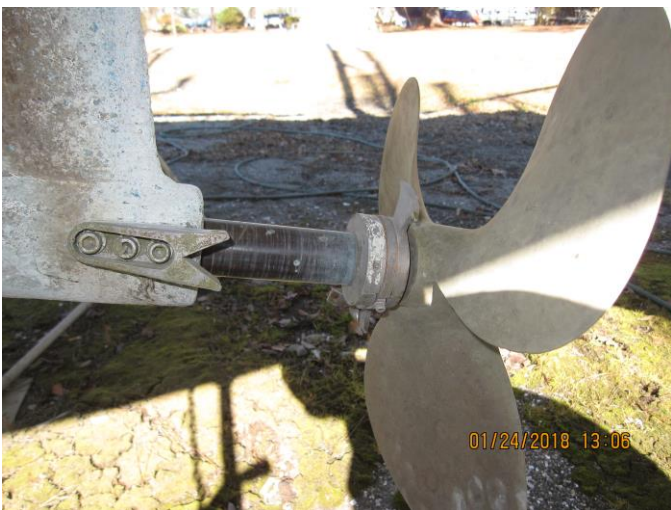
Spurrs line cutter on propshaft needs zincs.

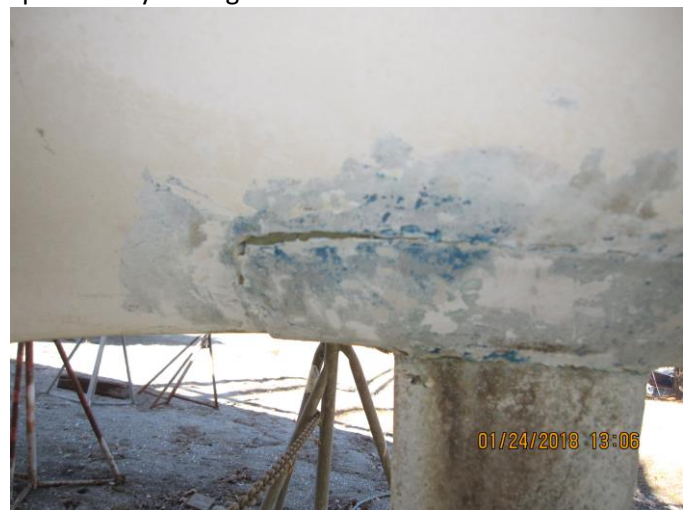
Cosmetic fairing cracking around propshaft strut

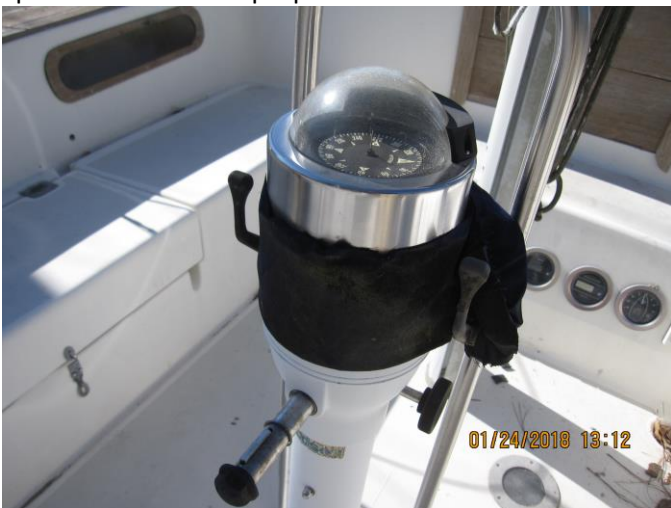
Compass void of fluid and cover shot

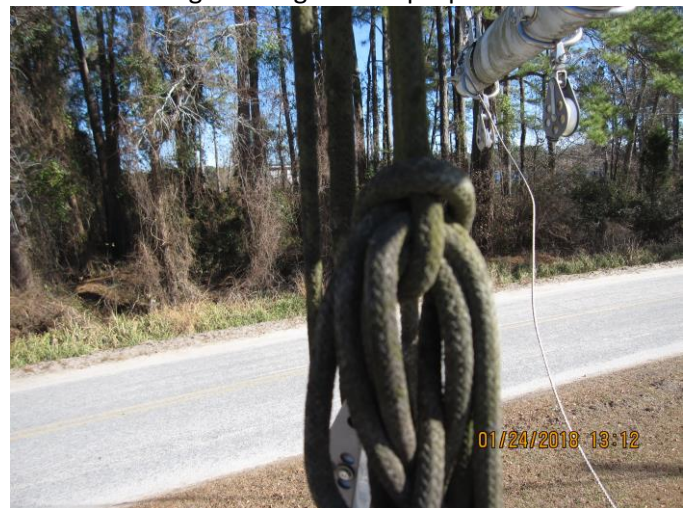
All running rigging shot

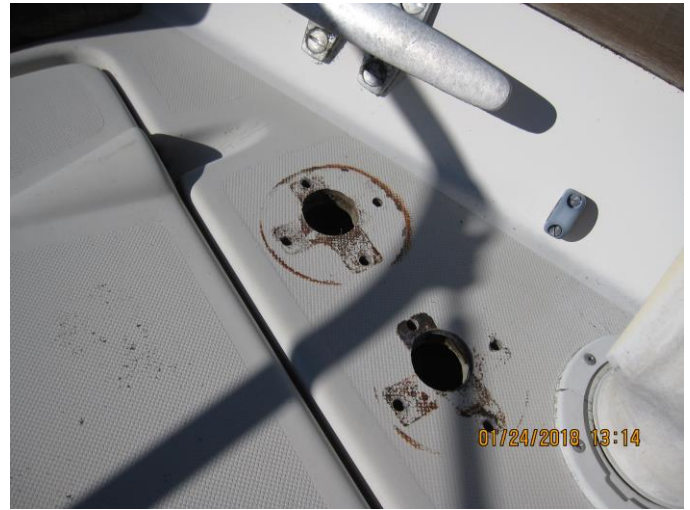
Windlass foot switches missing

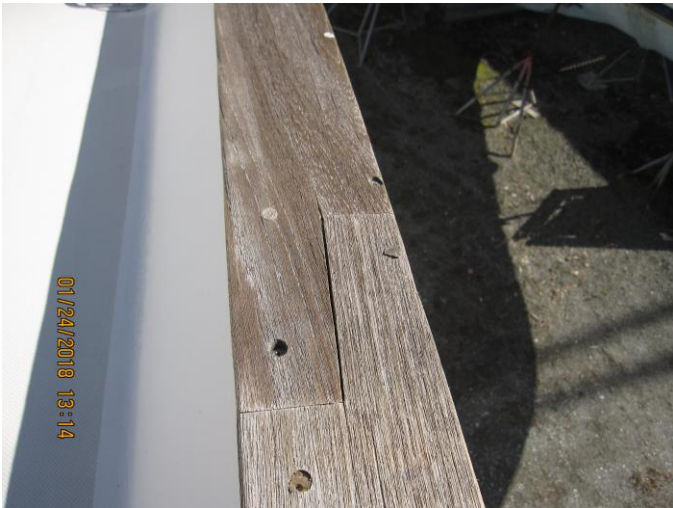
Many exposed toe rail plank fasteners exposed

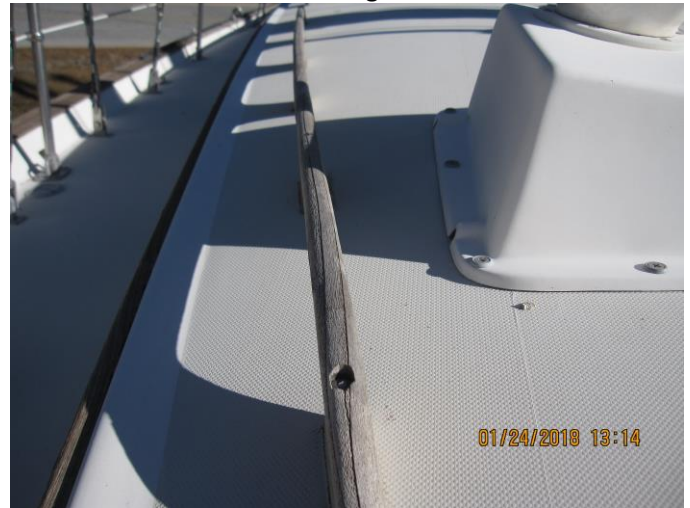
Hand rails thinned, fasteners exposed

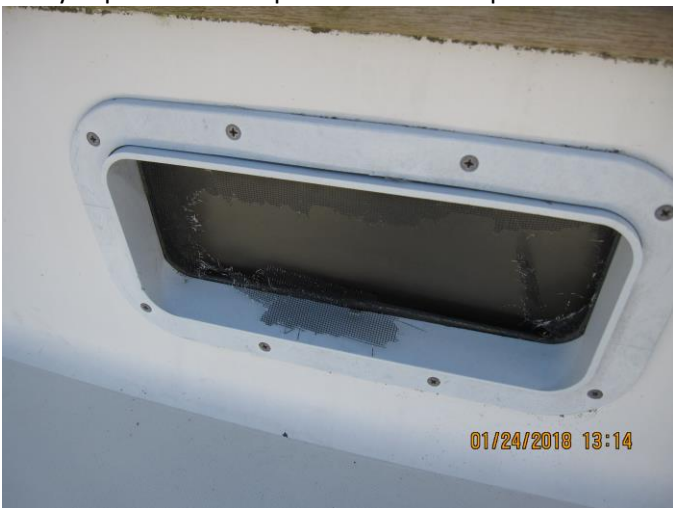
Portlight screens shot

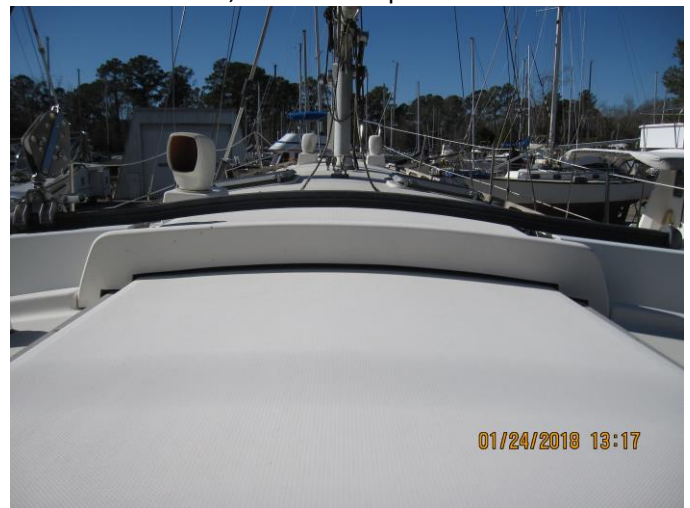
Mainsheet traveler bent upwards gently from loading. May be OK.

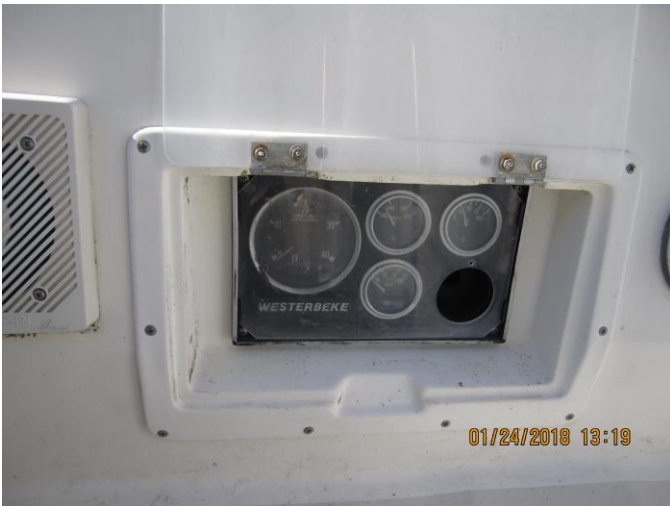
Engine instrument panel and cover to be replaced

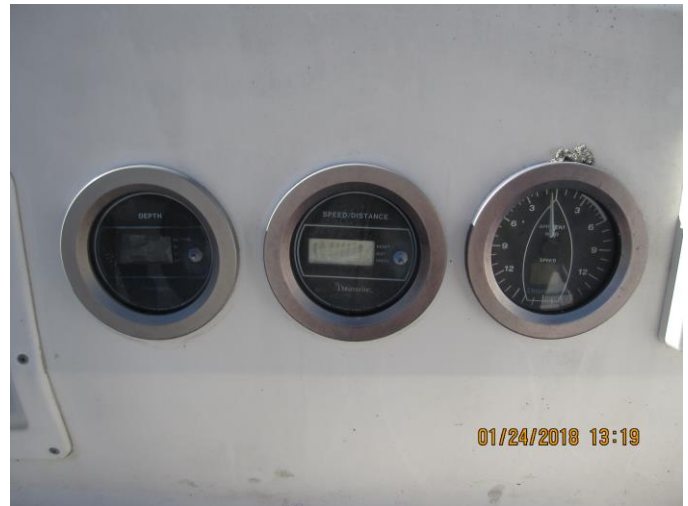
Vintage, sun damaged electronics ondeck

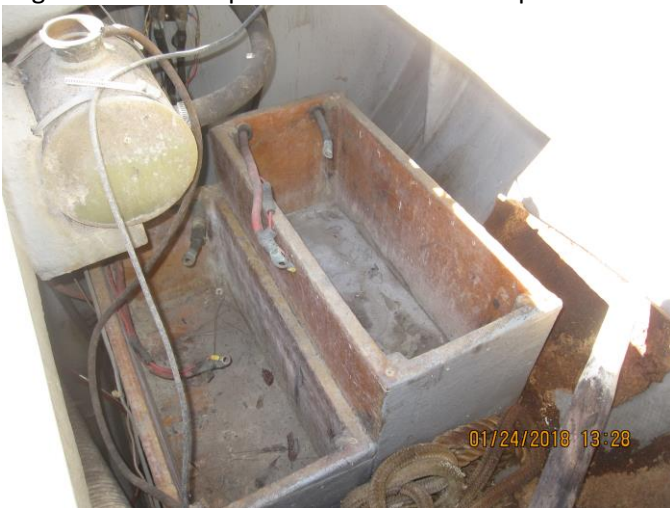
Battery boxes and old battery cables

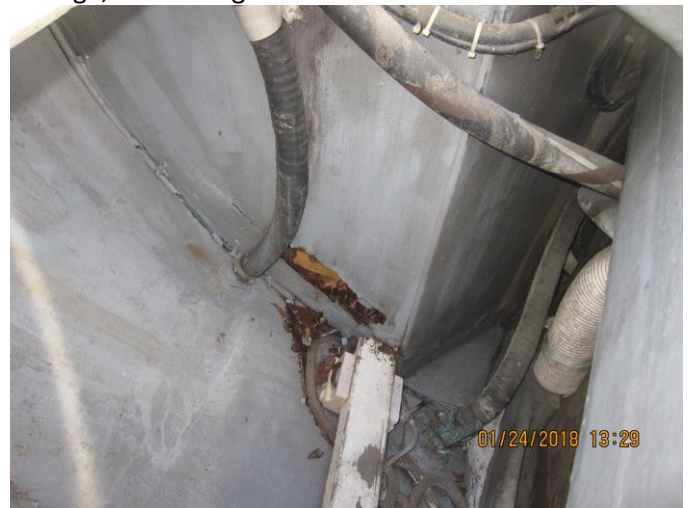
Water damaged minor bulkhead at forward end of port cockpit locker

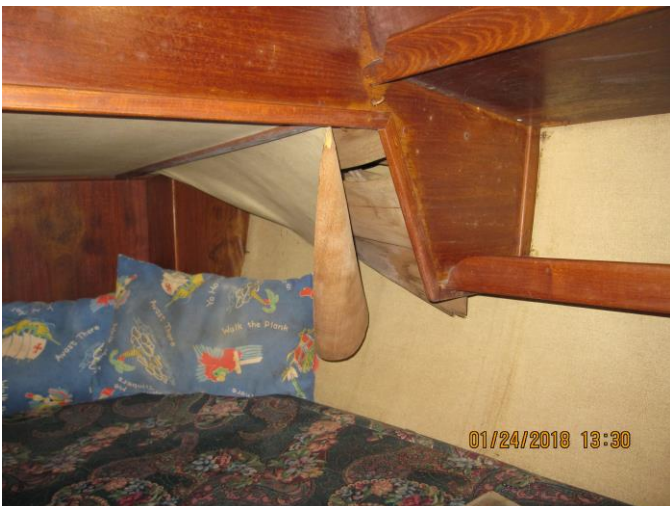
Water damage in quarterberth cabin. All soft goods should be replaced due to mildew/mold

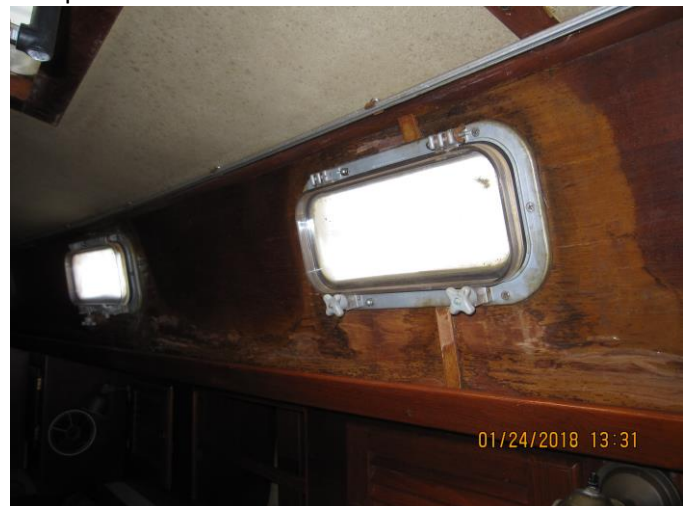
Water damaged wood around all portlights

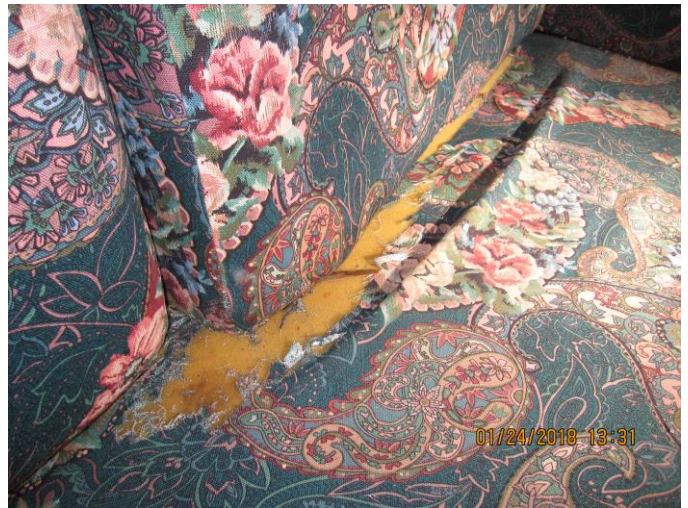
Vintage ripped upholstery

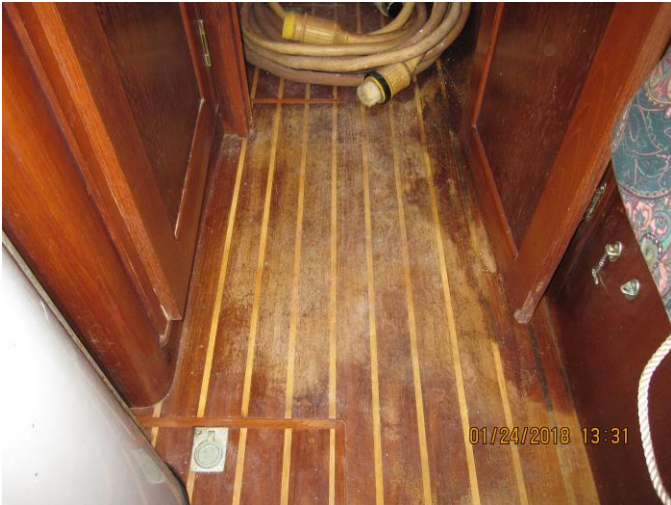
Water damaged cabin sole veneer

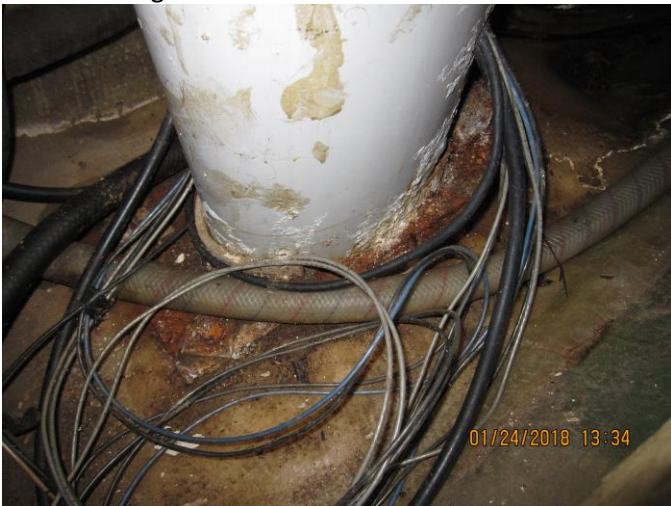
Corrosion at base of main mast

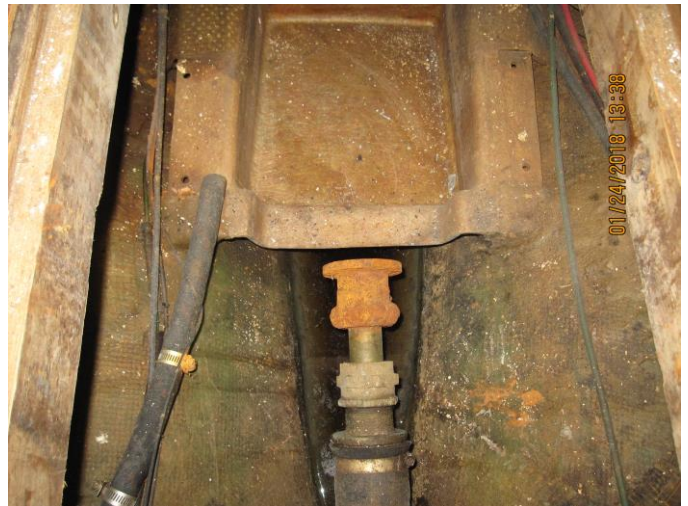
Walter vee-drive missing

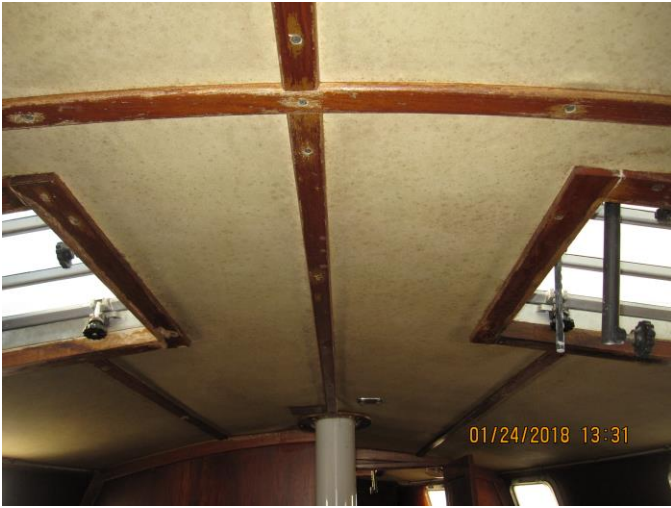
Mildew on vinyl panelboard headliner
